SHARED ROADWAY MASTERPLAN ASSESSMENT

GRASS MESA ROADWAY FOR GRASS MESA HOMEOWNER'S ASSOCIATION

MASTERPLAN ASSESSMENT

SGM Project # 2018-535

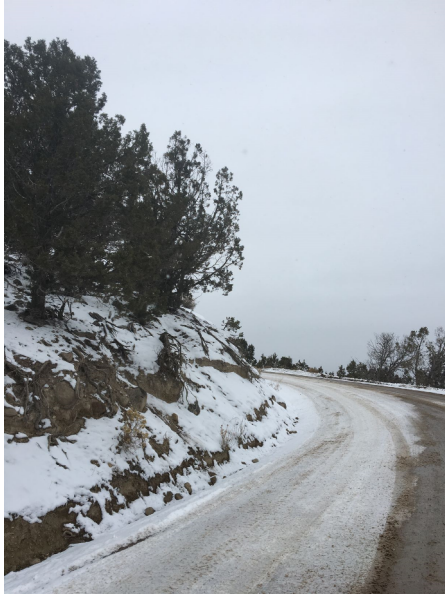
Addressing **general vegetation (photo)** should be considered. There are many locations where the juniper and pinyon do notably block the view around bends. We recommend anything over 3 feet tall within 10 feet of the ditch be cut back or removed. Do note that much of this area coincided with steep slopes that we also recommend on cut/fill work, which would thereby already remove vegetation.

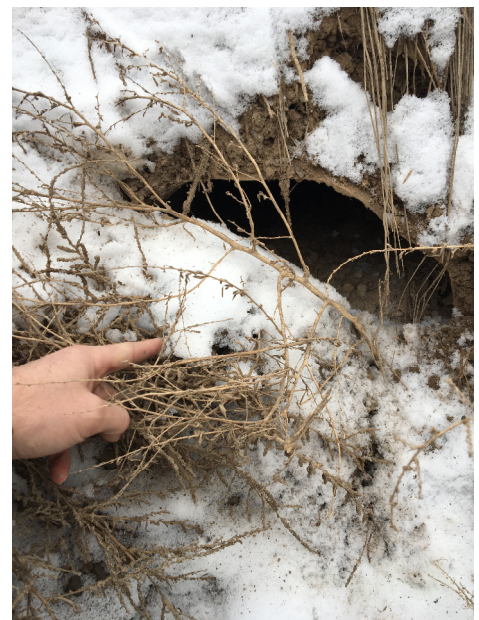
Upstream cleaning and weirs. Many of the locations had a recent ditch re-cut that was satisfactory but more permanent and intentional inlet controls are warranted for efficient flows into the pipe, thereby aiding in minimizing culvert clogging. This can be accomplished by ensuring a clear ditch section (V or trapezoidal), a vortex weir made with 6" – 12" angular rock, routing the flow with a bit of a "swing", and rip-rap at the mouth of the pipe itself. The latter elements of this recommendation were seen well at 0.31.

The weir helps re-concentrate flow to the pipe mouth, add a little energy and velocity to help flush the pipe more frequently, and protect the ditch upstream as the “V” shape acts as a level of trash collector, providing that easy to identify maintenance area which would hopefully concentrate future ditch maintenances points. The rip-rap in the “bowl” then protects the pipe mouth and helps to turn and energize the flow to aid in keeping the culverts flushed.

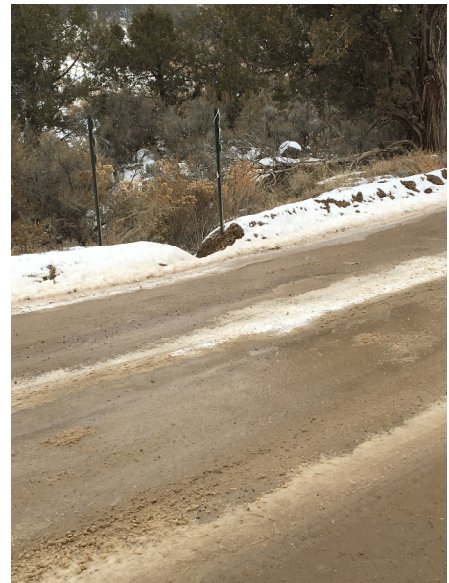
Shoulder drainage turnout. Where a culvert is not applicable, some intentional drainage release points should be added. These are simple excavation efforts. There were a few locations where it seemed this either naturally or perhaps with some intentional amendment occurred. Yet these areas seemed to be fairly small and offered little flow control once leaving the roadway, hence undercutting the road platform. A detail is provided for a pattern of making sure flows get well away from the edge of road.

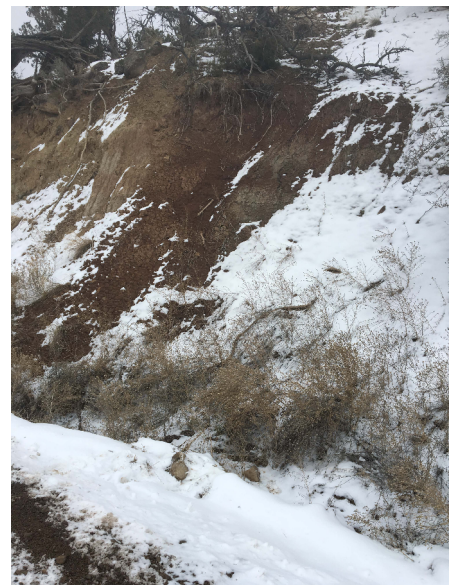
Steep slope alterations. Without topography or geotechnical information, it is difficult to get precise, but it appeared that the soils in the area did not stay together if they were steeper than 1:1 (stress / sloughing cracks can be seen in the photo at right). There are several areas where the cut slope above the roadway was sloughing off and then collecting in the ditch where steeper than this ratio. It would seem the best alternative is to lay those

slopes back to a maximum 1:1 or flatter. This will improve visibility and help reduce the negative impact these slopes have on ditch maintenance.

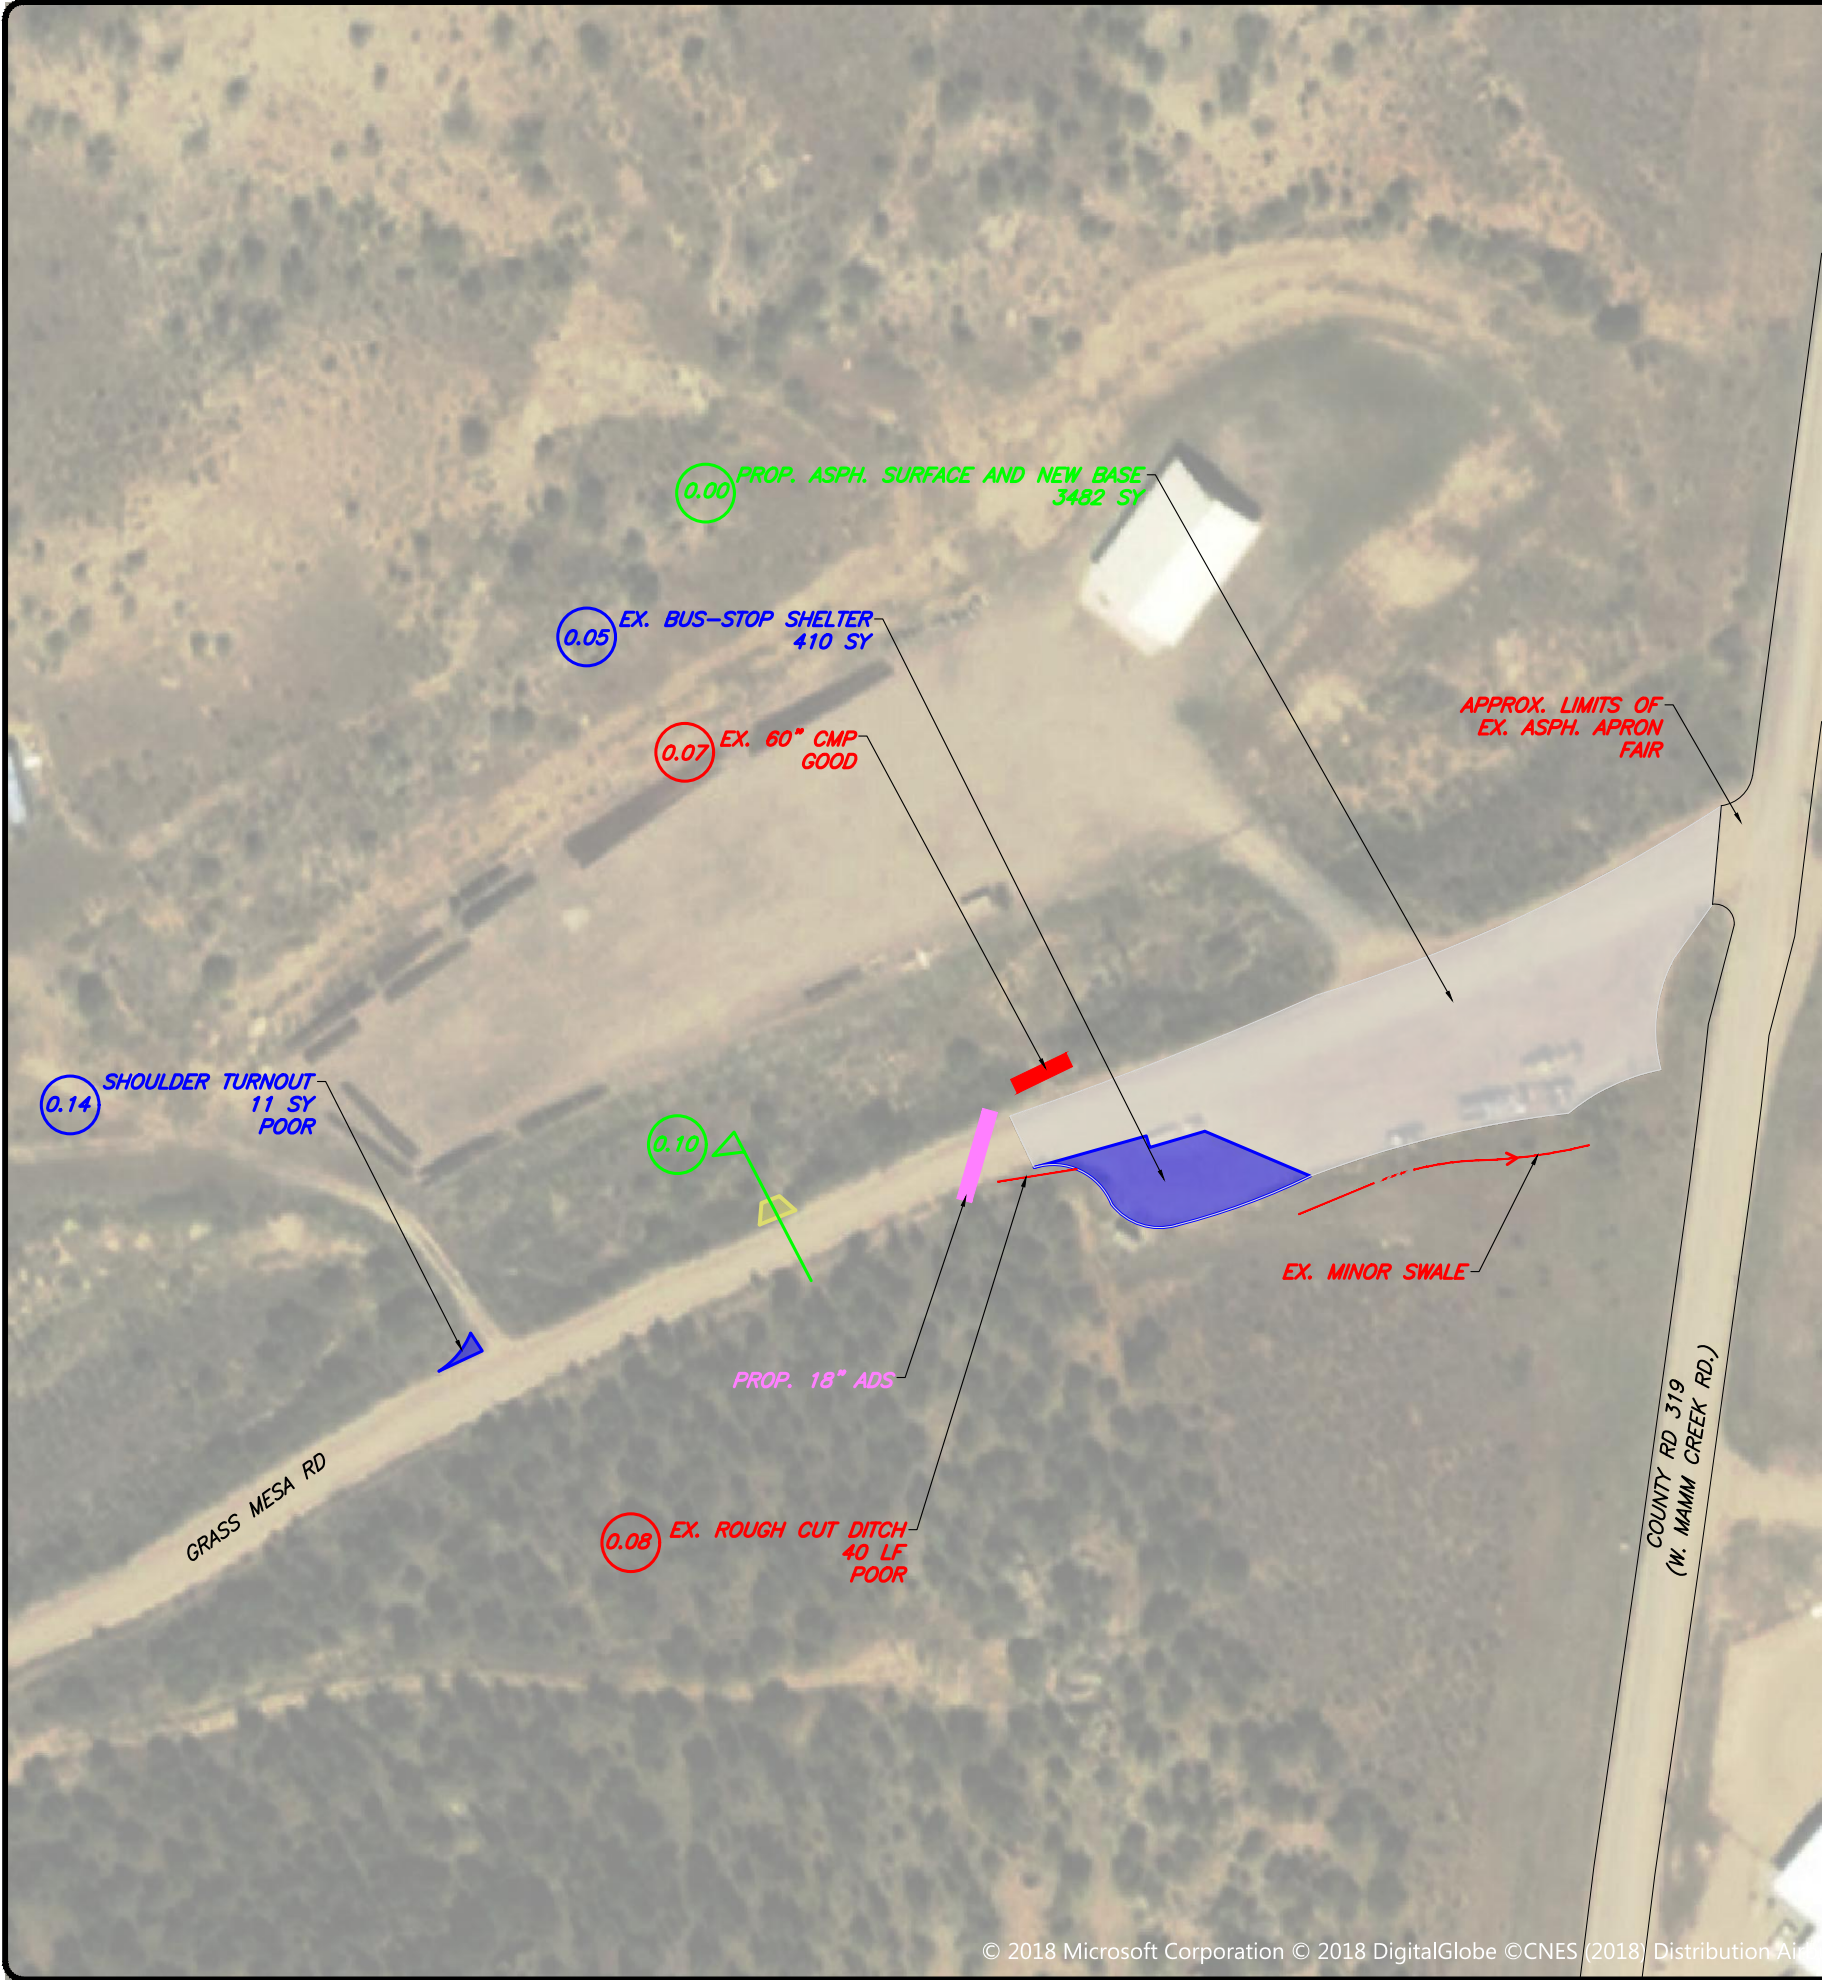
#	Revision	Date	By:
1			
Project Milestone: Not For Construction			
Job No. 2018-535.001			
Drawn by: RPF			
Date: 01.11.2019			
QC: JS PE: RB			
File: Grass-DW-Parking			
Title:			
Road Improvements - Parking Area			
Dwg No. 2			
Of: 5

ID	Element	Condition	Description	Details
0.00	Surface	FAIR	Pave parking area with asphalt	
0.05	Bus-stop	POOR	Improve poorly graded bus-stop	
0.07	Ex. 60" CMP	GOOD	Monitor inlet/outlet for cleaning	
0.08	Ditch	POOR	Install Prop. 18" ADS and re-grade	2
0.10	Section	POOR	Fill steep slope for turnout	5, 7
0.14	Shoulder	POOR	Build up turnout, rip-rap to ditch	6, 7

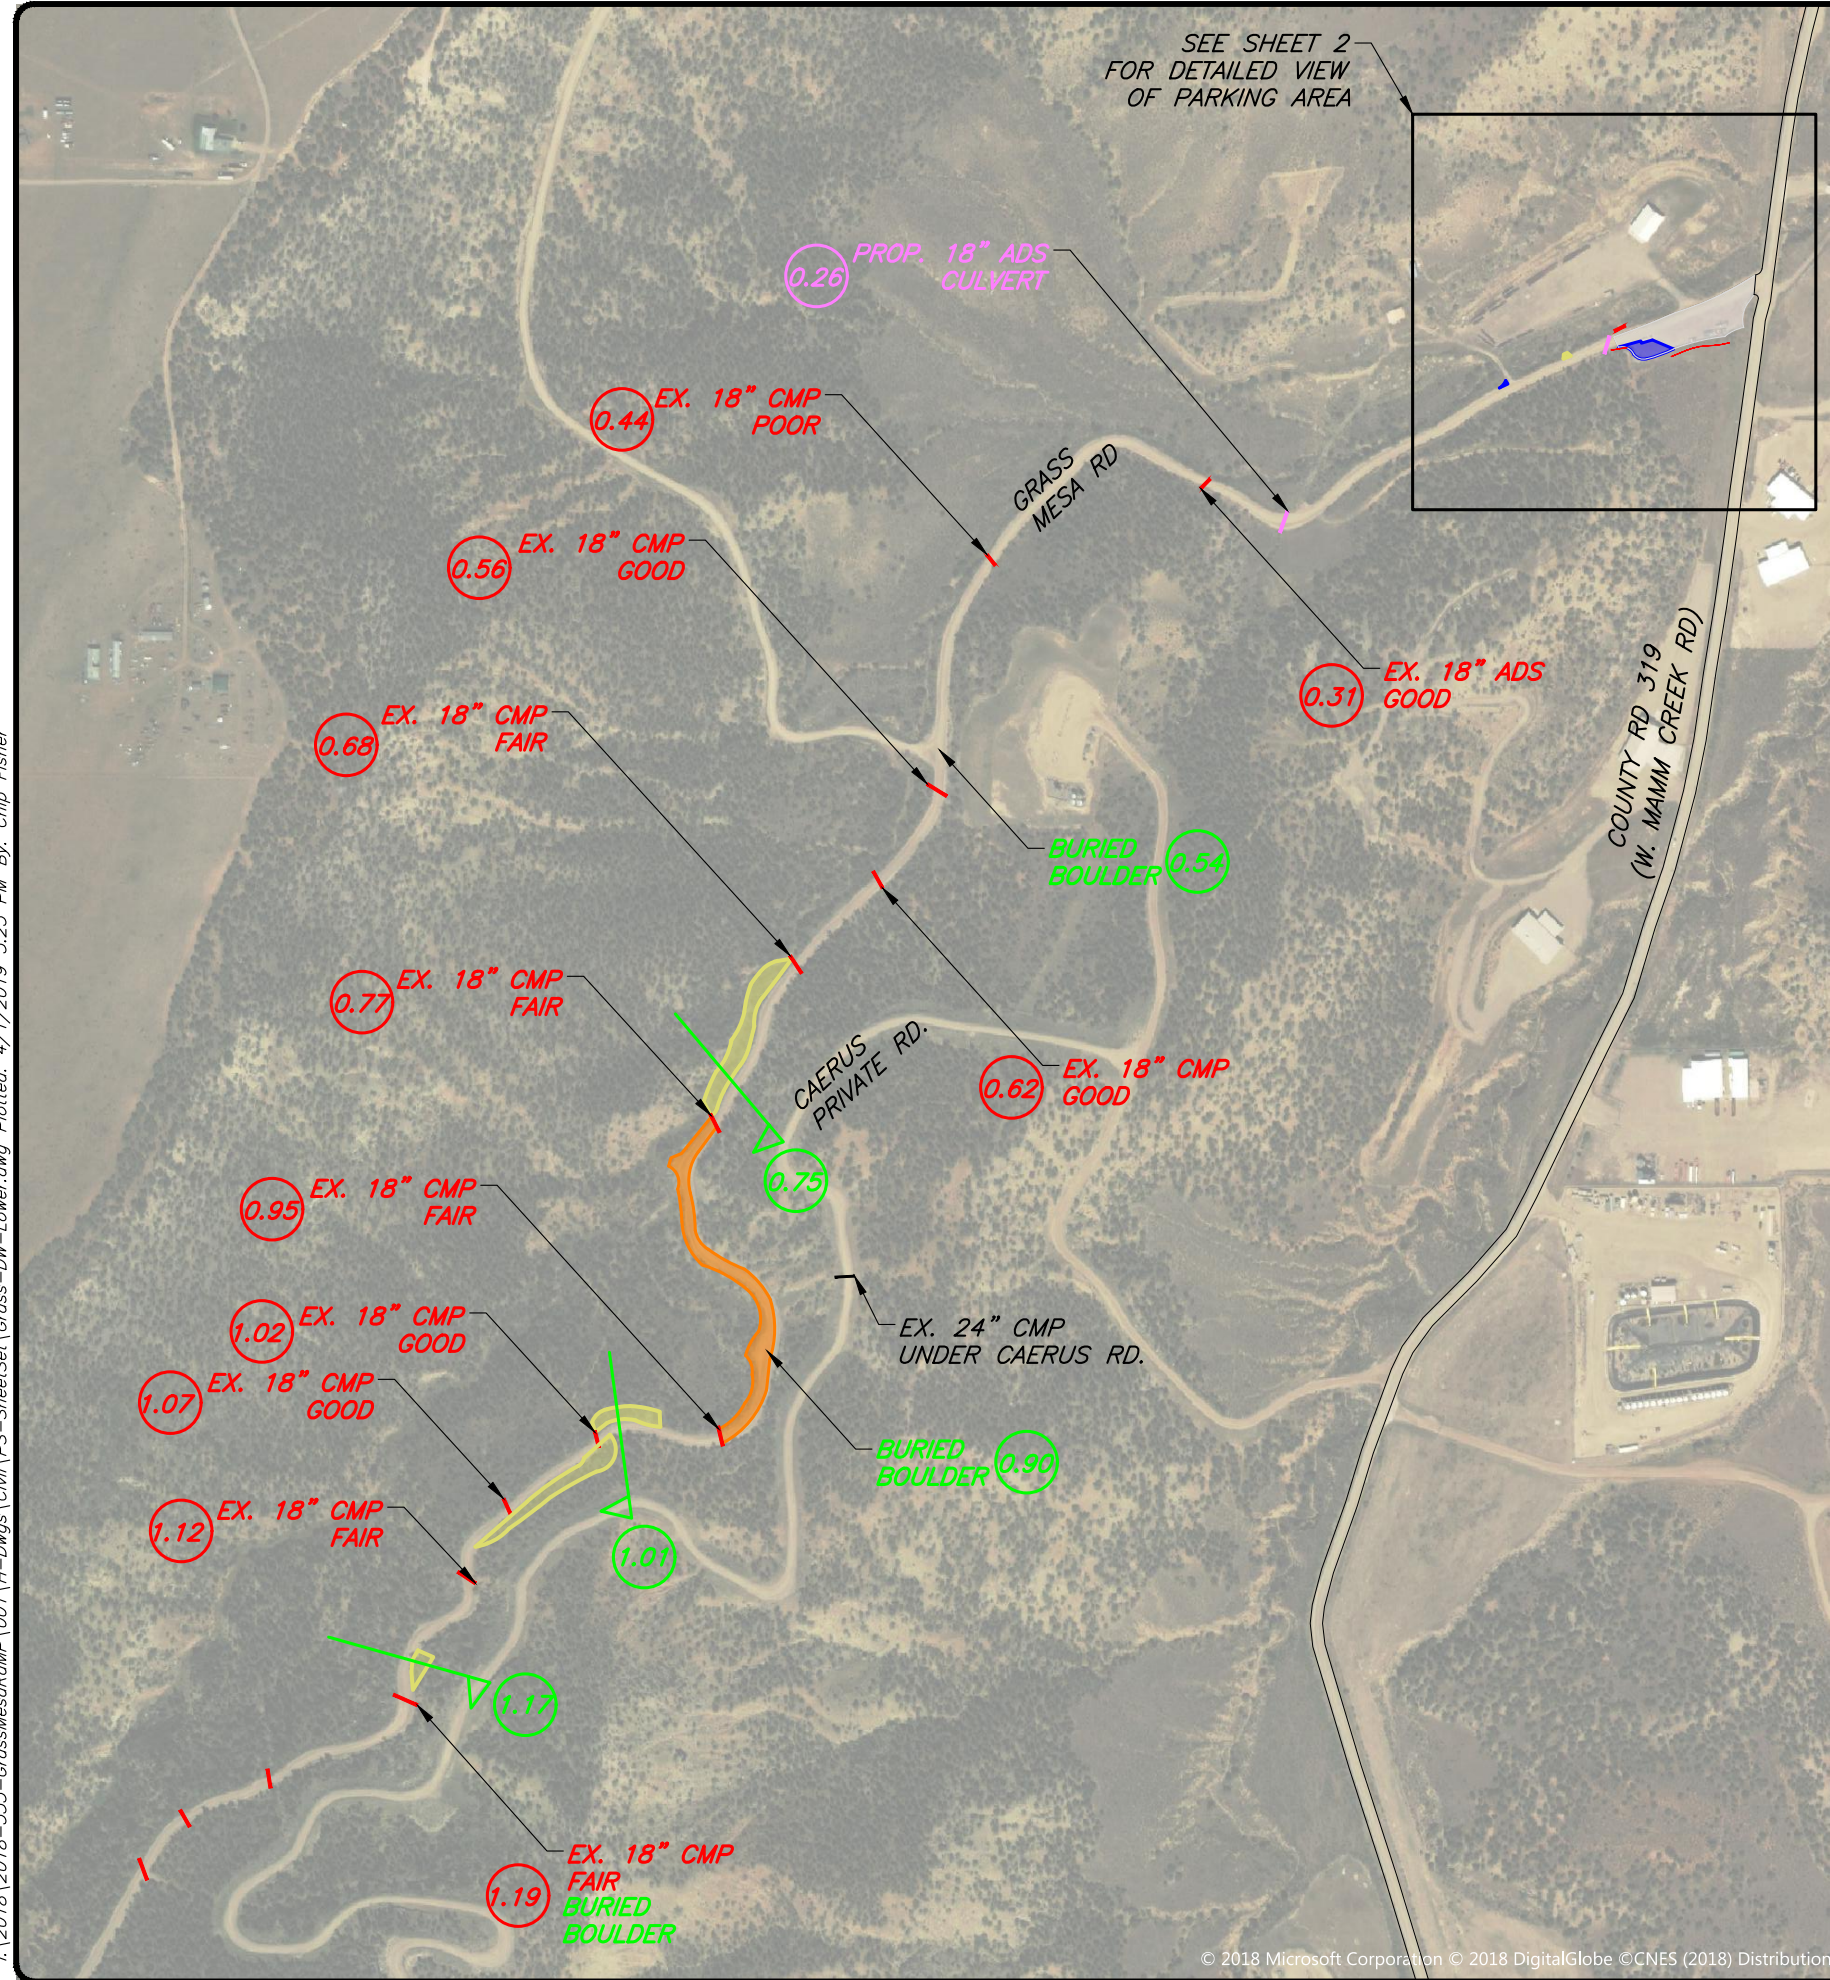
#	Revision	Date	By:
1			
Job No. 2018-535.001			
Drawn by: RPF			
Date: 01.11.2019			
QC: JS PE: RB			
File: Grass-DW-Lower			
Title:			
Road Improvements - Lower Driveway			
Dwg No. 3			
Of: 5

ID	Element	Condition	Description	Details
0.26	Prop. ADS	N/A	Prop. 18" ADS culver & construct minor weir 6"-12" rock	1-3
0.31	Ex. CMP	GOOD	Construct minor weir 6 - 12" rock	2, 3

0.44	Ex. CMP	POOR	Clogged and damaged. Replace with 18" ADS & construct minor weir	1-3
0.54	Boulder	N/A	Buried boulder under road	
0.56	Ex. CMP	GOOD	Monitor inlet/outlet for cleaning

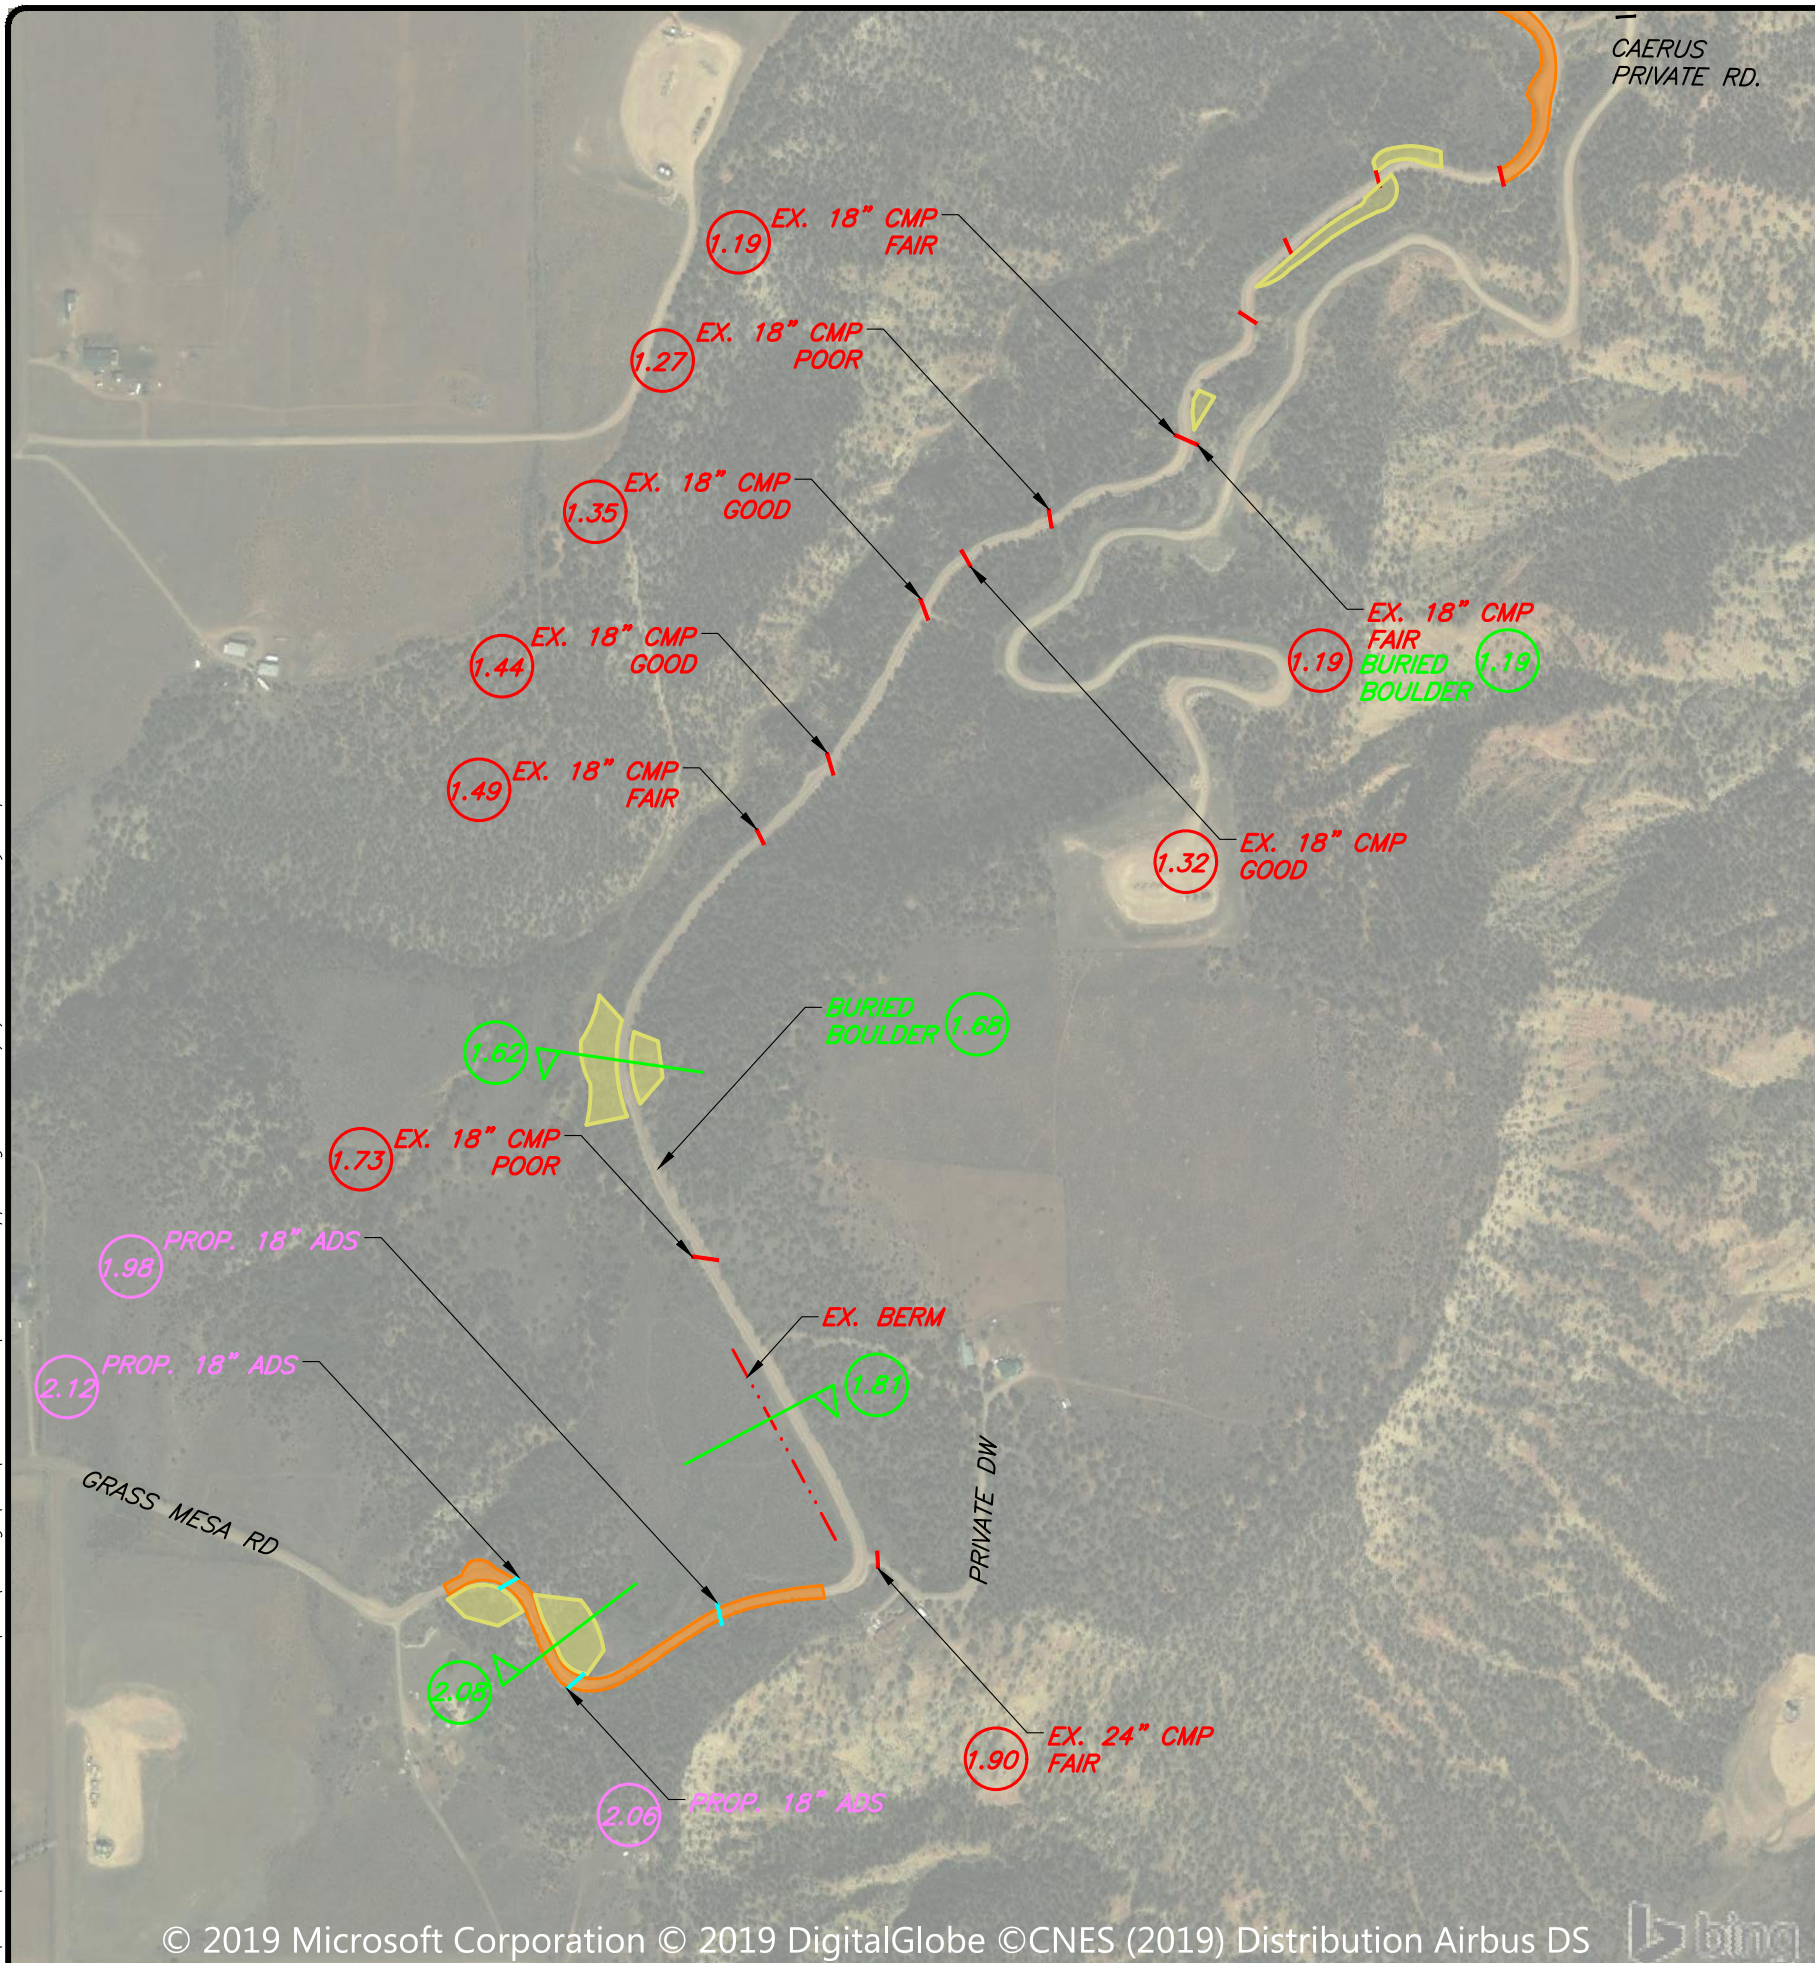
<i>ID</i>	<i>Element</i>	<i>Condition</i>	<i>Description</i>	<i>Details</i>
1.17	Section		Cut/fill steep slopes for visibility	5
1.19	Ex. CMP	FAIR	Clean debris in culvert, improve ditch flow	2,3

1.19	Boulder	N/A	Buried boulder under road	
1.27	Ex. CMP	POOR	Clogged and damaged. Replace with 18" ADS & const. minor weir	1-3
1.32	Ex. CMP	GOOD	Monitor inlet/outlet for cleaning

1.62	Section		Cut/fill steep slopes	5
1.68	Boulder	N/A	Buried boulder under road	
1.73	Ex. CMP	POOR	Clogged and damaged. Replace with 18" ADS & const. minor weir	1-3
