## Road Assessment and Maintenance Reserve Report

## South Fork Ranches Asphalt Roadways

South Fork Ranches Master Home Owners Association

August 2010

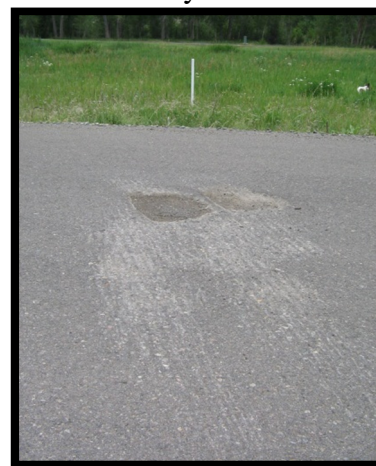
Potholes, feather patches, and other “temporary maintenance” measures should be undertaken annually, or at the appropriate time. Some potholes may need to be repaired outside of normal maintenance season if there is a safety or vehicle damage concern. Feather patches may be desired in areas where surface irregularities have developed, or damage has occurred to minimize further degradation. A good example of a candidate for a feather patch would be as shown in the photo to the right where apparently a chained snow removal vehicle spun the tires and gouged the asphalt (E. Riverside Ct.).

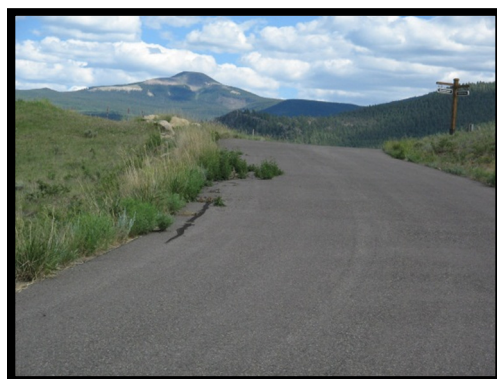
An aggressive weed control plan should be pursued, as significant intrusion can quickly deteriorate the asphalt mat. There are several areas throughout the project where shoulder weed intrusion was noted, such as on Hillside Lane as shown in the picture to the left. Where roots have invaded the road space (such as on E. Riverside Court), the road material may have to be removed, the roots severed, the aggregate material properly replaced, and a full depth patch constructed.

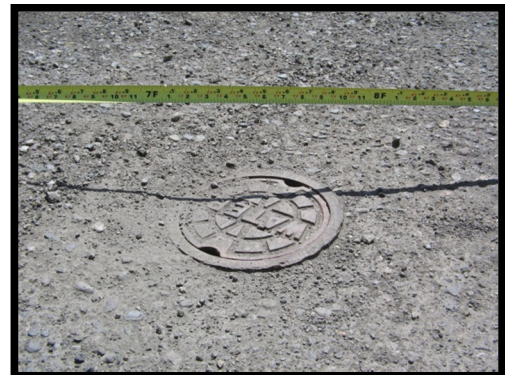
For the Cliffside roads, it would appear there may be subgrade, drainage, and utility trench issues which have caused enhanced deterioration. The photo to the right shows the magnitude of settlement which has occurred most likely over a water main installation.

Again, due to the severity of the poor road condition, significant reconstruction may be the most economical long term solution, including similar construction measures as indicated above for the Alder Creek Meadows roads. Hillside Lane in the Timbers shows the same type of surface issues as the Cliffside roads, again

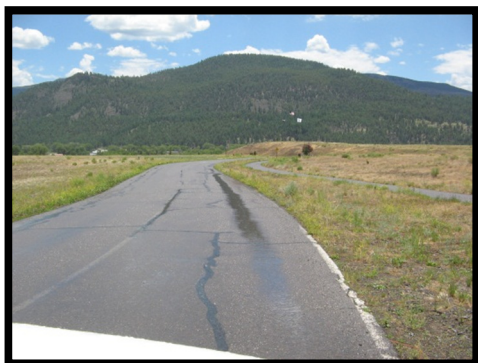
After the roads mentioned above, the next street showing some signs of structural distress is Rio Grande Club Trail from North River Road to the Rio Grande Club House, primarily on top where some rutting and shoulder cracking is occurring. The rutting is apparent in the picture to the left, where the water is standing in the roadway along the wheel path. This section of the road has the highest potential for ADT of all the SFRMHOA streets, shown at 3,318 vehicles per day in the Road Summary Spreadsheet. It also is the road experiencing

the highest present day traffic. It is likely that this road will require significant refurbishment as well, potentially including asphalt pulverization, aggregate addition, and new asphalt paving along with proper shouldering and road side ditches. Improvements should be designed as appropriate for the expected traffic (the current configuration of 2.5 inches of asphalt is shown to have a 23 year design life in the WT report. Therefore, the indicated refurbishment will have a design life in excess of this as long as 2.5 inches or more of new asphalt is placed).
