SHARED ROADWAY MASTERPLAN ASSESSMENT

GRASS MESA ROADWAY FOR GRASS MESA HOMEOWNER'S ASSOCIATION

MASTERPLAN ASSESSMENT

SGM Project # 2018-535

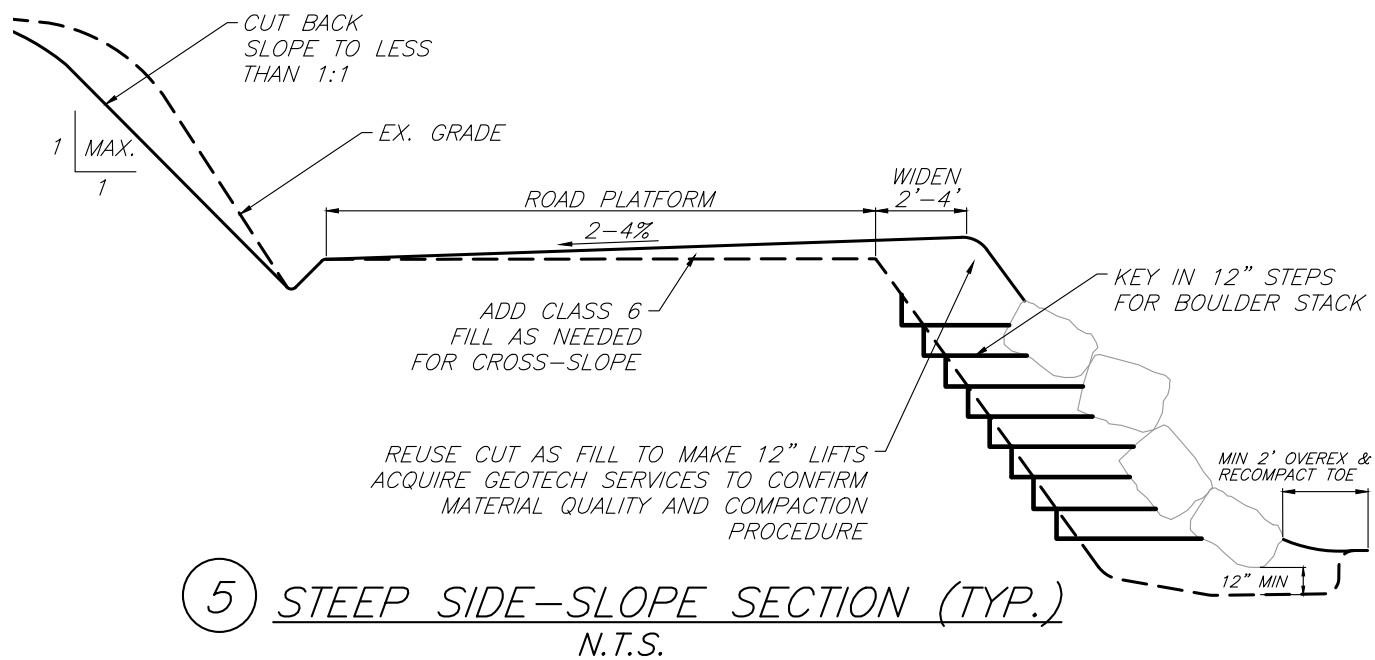
⑤ STEEP SIDE-SLOPE SECTION (TYP.)
N.T.S.

Steep slope alterations. Without topography or geotechnical information, it is difficult to get precise, but it appeared that the soils in the area did not stay together if they were steeper than 1:1 (stress / sloughing cracks can be seen in the photo at right). There are several areas where the cut slope above the roadway was sloughing off and then collecting in the ditch where steeper than this ratio. It would seem the best alternative is to lay those
