## Road Assessment and Maintenance Reserve Report

## South Fork Ranches Asphalt Roadways

South Fork Ranches Master Home Owners Association

August 2010

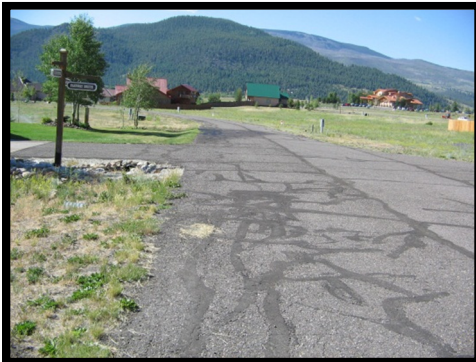
Alder Creek Meadows and Cliffside subdivisions, and Hillside Lane in the Timbers subdivision. In Alder Creek Meadows there is significant cracking and surface deterioration, as apparent in the picture to the left, which ages the roads beyond their years. Due to the severity of the cracking, raveling, marginal drainage, and lack of underlying road base, it may be most prudent for long term sustainability to perform a complete reconstruction of these roads. This would include pulverization of the asphalt and utilizing the existing road bed as much as practical, then performing subgrade stabilization where necessary, reshaping, supplementing with appropriate aggregate base, and repaving with new asphalt, along with drainage improvements and other associated reconstruction activities.
